TS-AMD-86612-4
September 1987

AERIAL PHOTOGRAPHIC ANALYSIS OF THE SHELL RIVERFRONT AND
REFINERY SITES

Wood River, Illinois

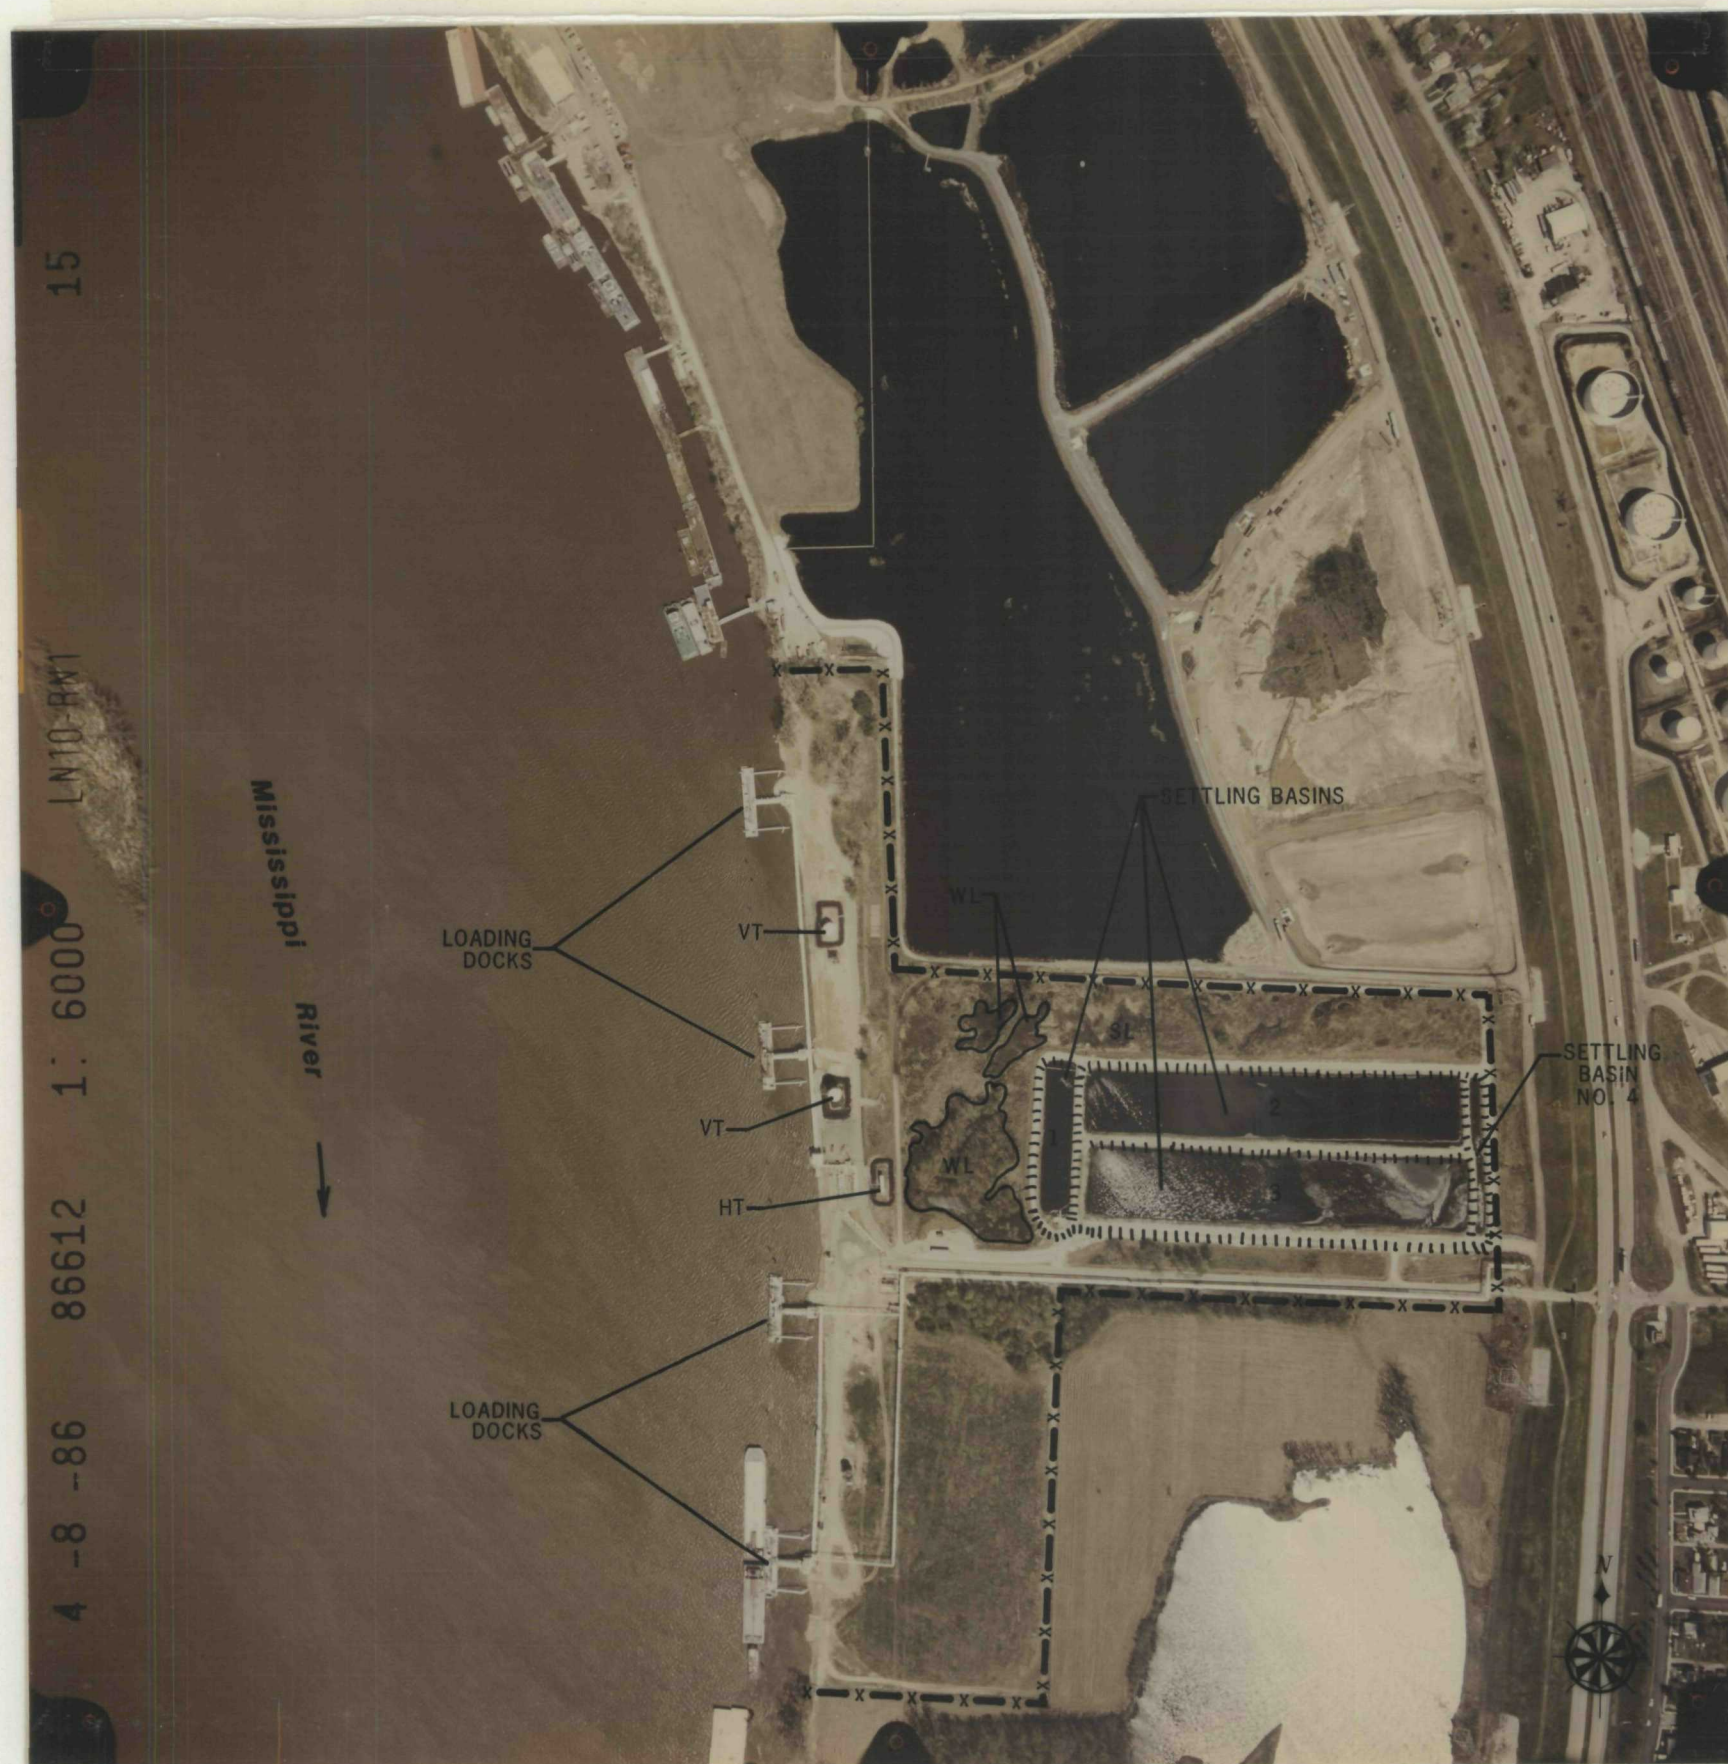
Figure 3. Shell Riverfront site, April 8, 1986. Approximate scale 1:6000.

Figure 3 shows that the site is well fenced. Four oil loading docks are located along the river. No slicks or sheens are evident at any of these docks. Significant features are:

Settling Basins 1-4: All four of the basins contain liquid and appear to be unlined.
No seepage is visible.

Three contained storage tanks are present at the site.

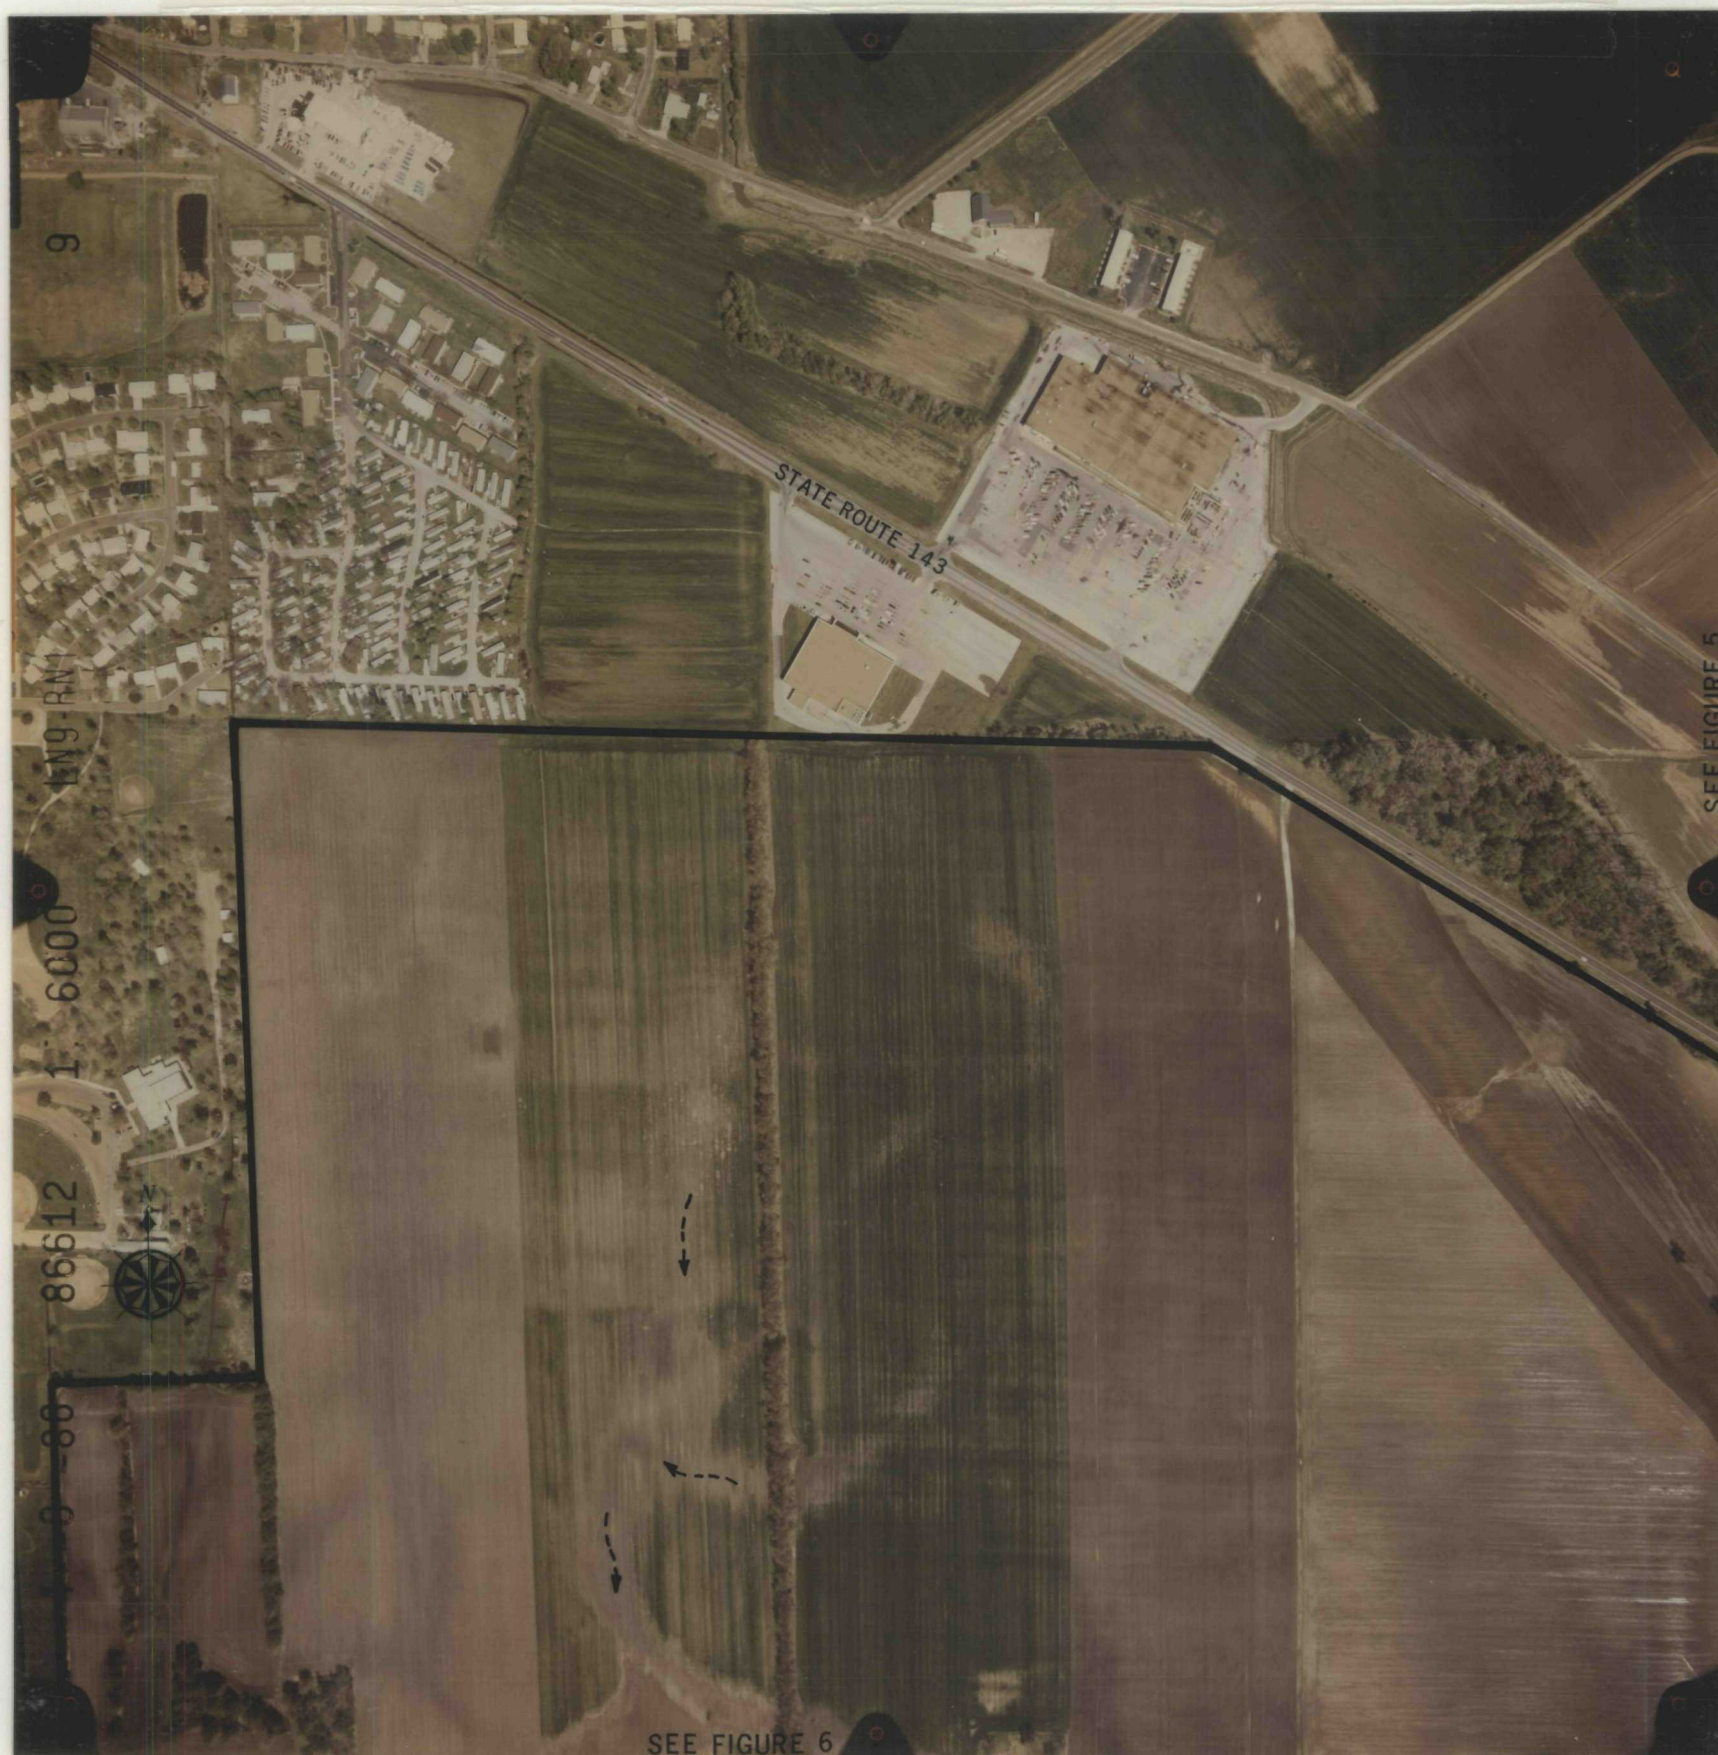
Figure 4. Shell Refinery site, April 8, 1986 (1 of 9). Approximate scale 1:6000.

Figure 4 shows the northern edge of the site. This area consists of agricultural land with no industrial activity or potential contamination sources visible. Drainage in this area is to the south. The site boundary in this area is unfenced.

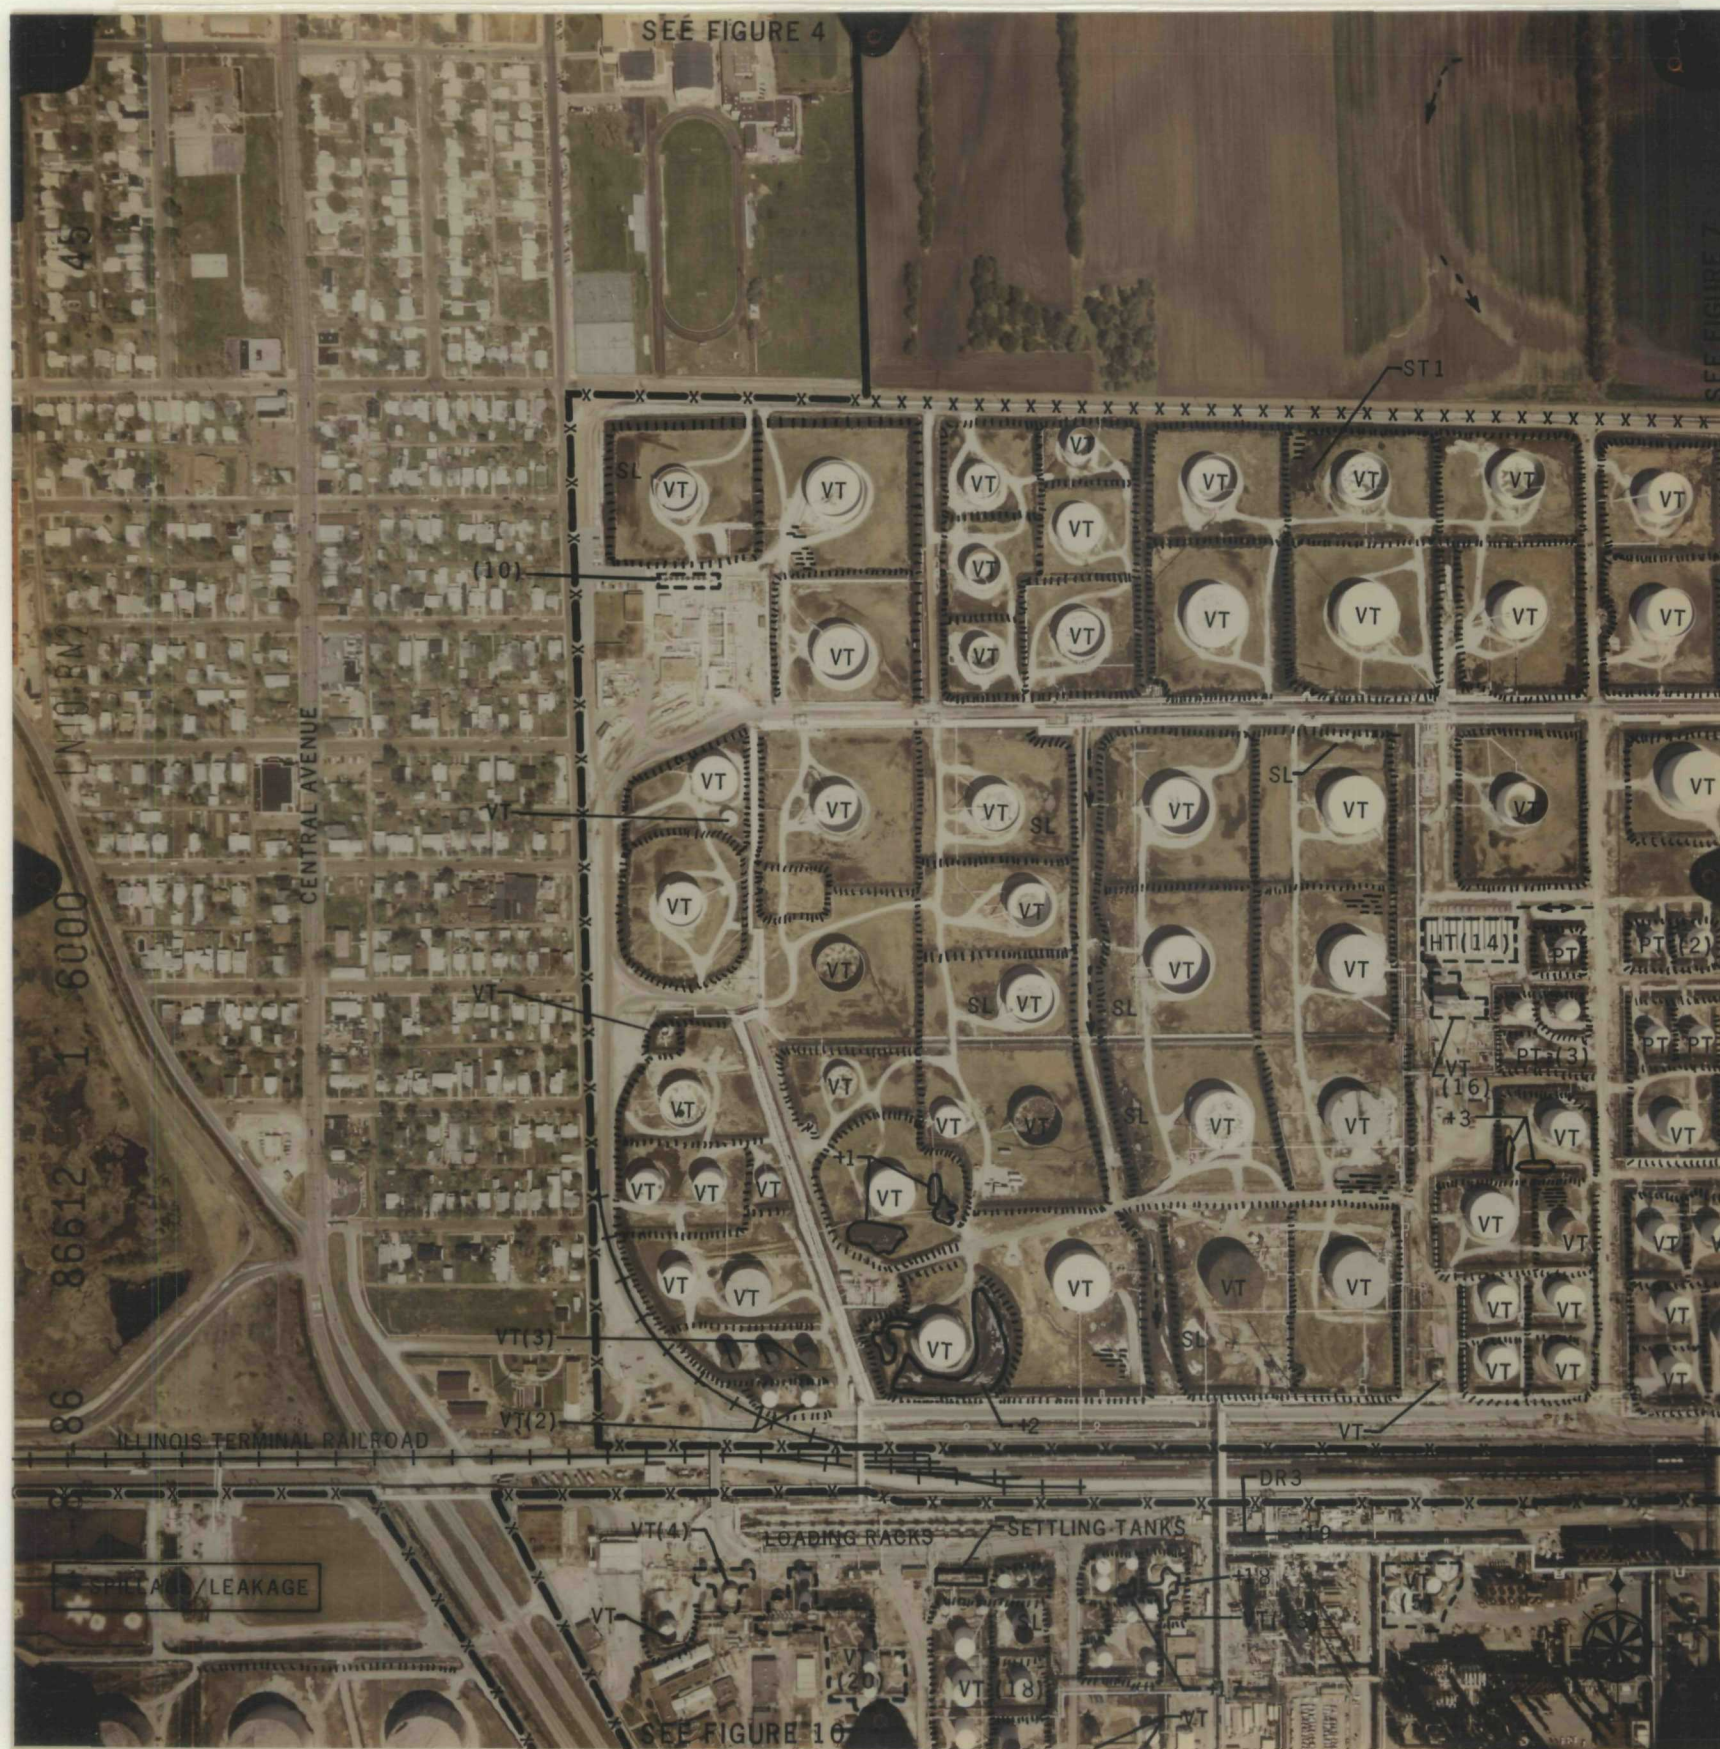
Figure 6. Shell Refinery site, April 8, 1986 (3 of 9). Approximate scale 1:6000.

Figure 6 shows a section of the bulk oil storage area. This area is completely fenced. A major drainage channel runs south through this area. The eventual destination of this channel is not apparent. Significant features are:

- +1 and +2: These are heavy, dark oily spills within containment dikes. The adjacent tanks are the likely source but they do not appear to be leaking.
- +3: This orange-hued spill is visible both within containment and outside containment dikes. The source of this liquid is not apparent.
- ST1: The adjacent tank doesn't appear to be the source of this dark oily stain within containment.

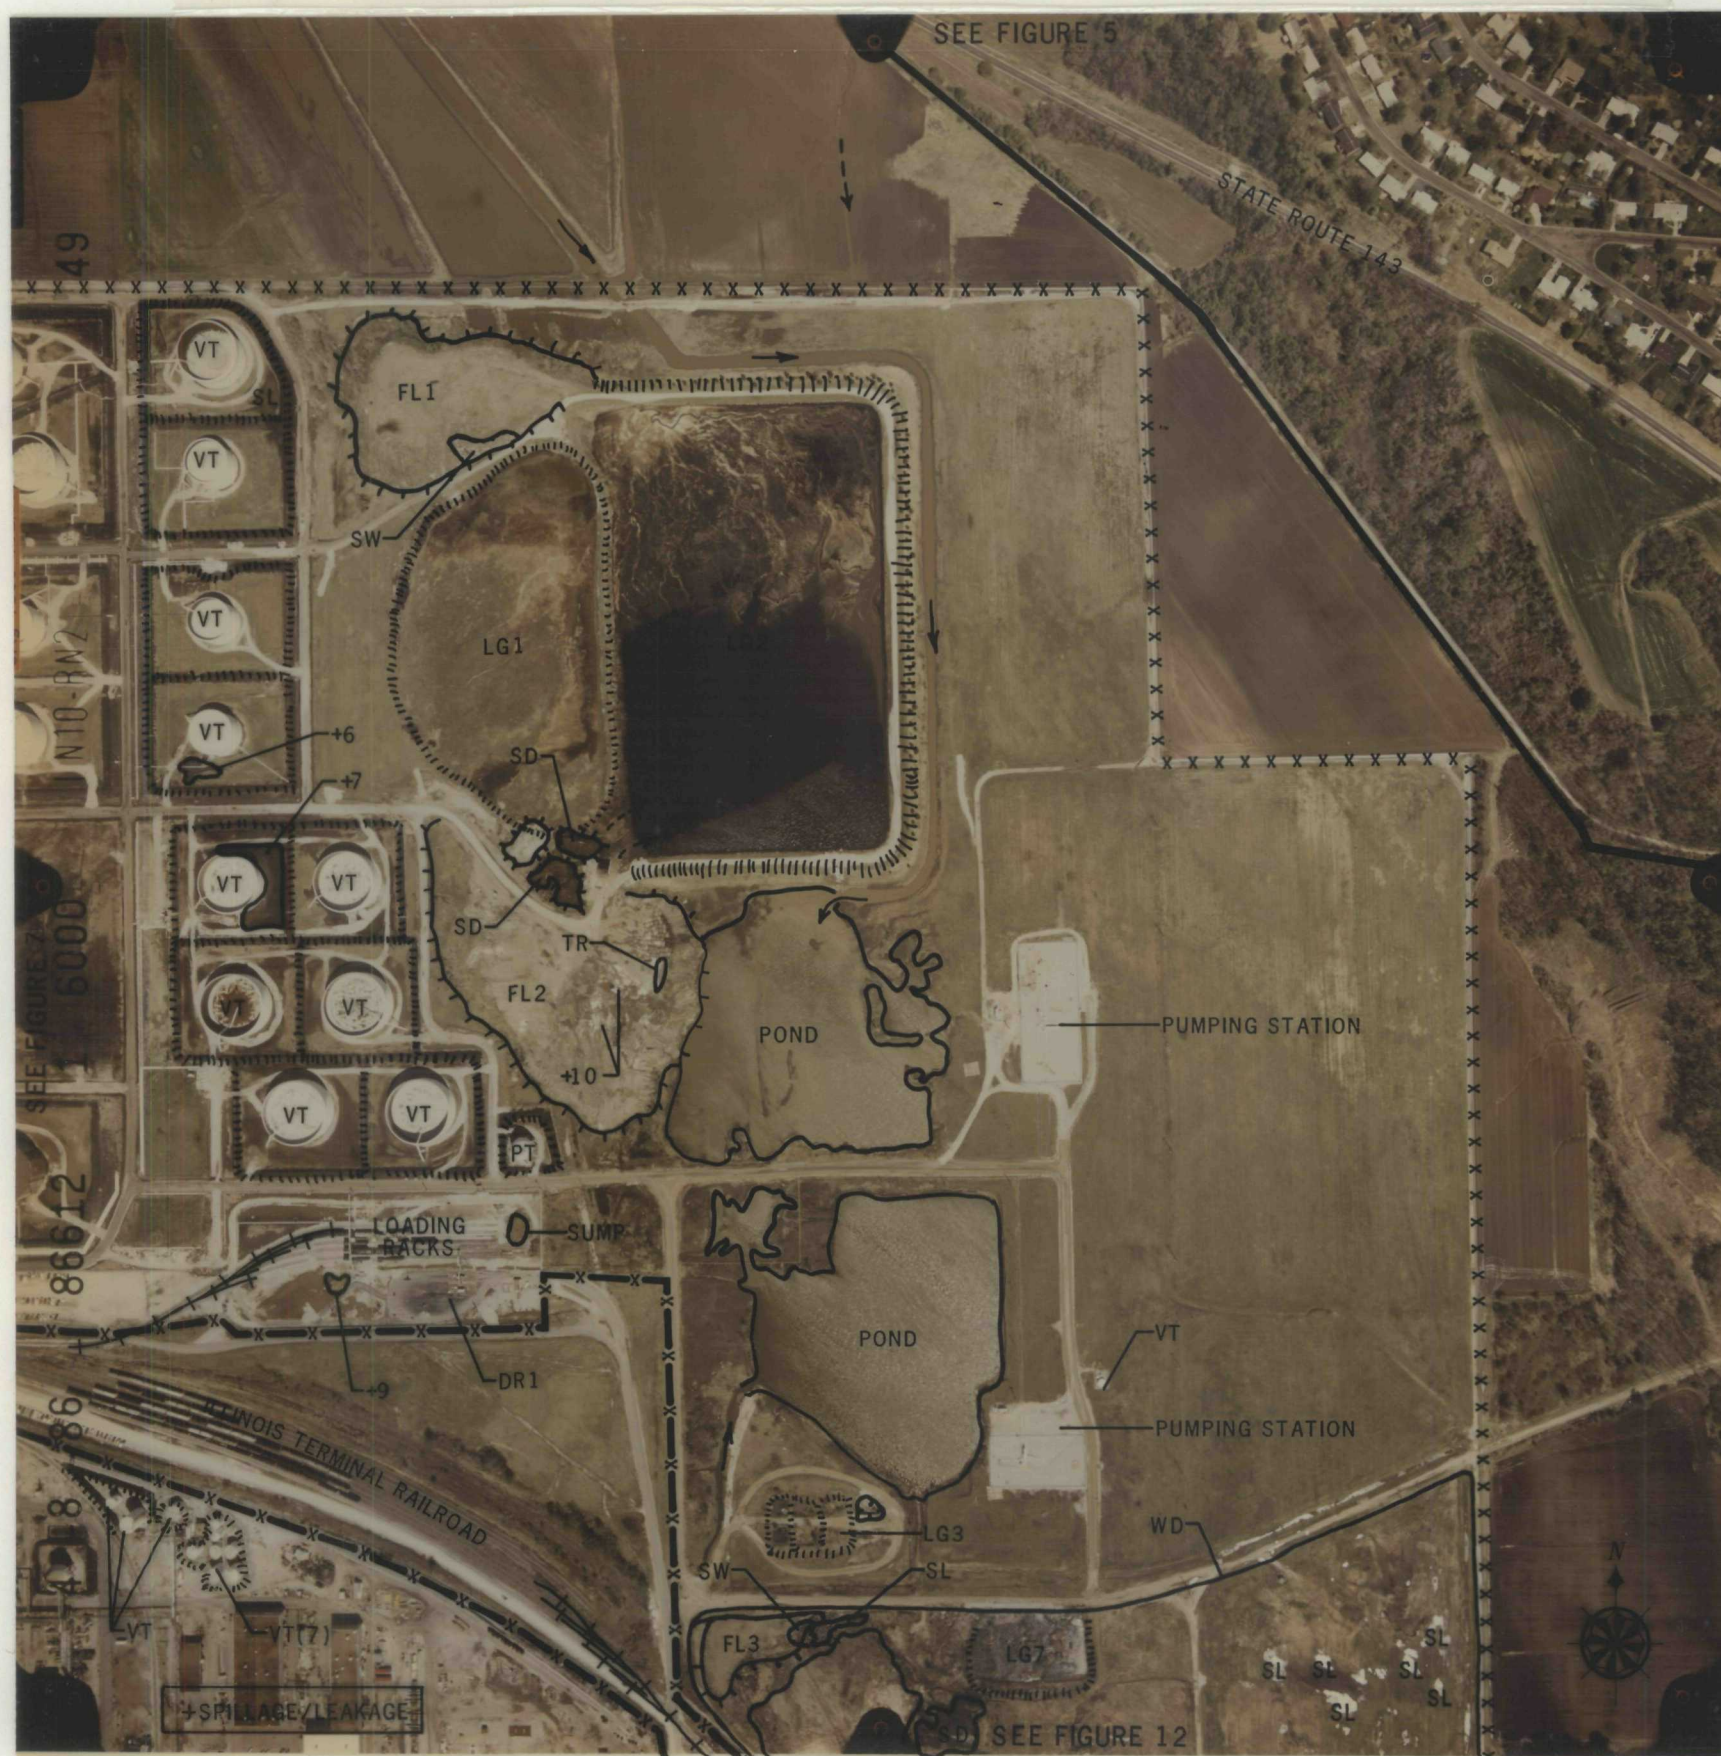
Figure 8. Shell Refinery site, April 8, 1986 (5 of 9). Approximate scale 1:6000.

A second area of waste disposal activity is present on Figure 8. This area is well-fenced. Drainage in this area is to the south and is diverted around the lagoons 1 and 2 into the two ponds. These ponds are vulnerable to contamination from LG1 and LG2 and also leachate from any waste which may have been buried at FL2. Significant features are:

- LG1: This unlined lagoon is almost empty at this time.
- LG2: This unlined lagoon contains dark oily liquid, probably a petroleum waste.
- LG3: This feature consists of a series of six unlined pits. Three of which contain liquid (possibly standing water). A raised road way runs through these pits possibly for dumping from tank trucks.
- FL1: This mounded area is probably a landfill. A deposit of solid waste is noted along the southern slope and scattered over the surface.
- FL2: Two large sludge deposits are on the north side of this fill area. These are draining into LG2. A trench can also be seen at this area.
- +10: These are pools of white liquid which appear to have been dumped on the fill surface.
- DR1: A small number of drums are stored at this point. No leakage is visible.

Additional features are a sump near the loading racks. Features located in the WD are discussed on page 26.

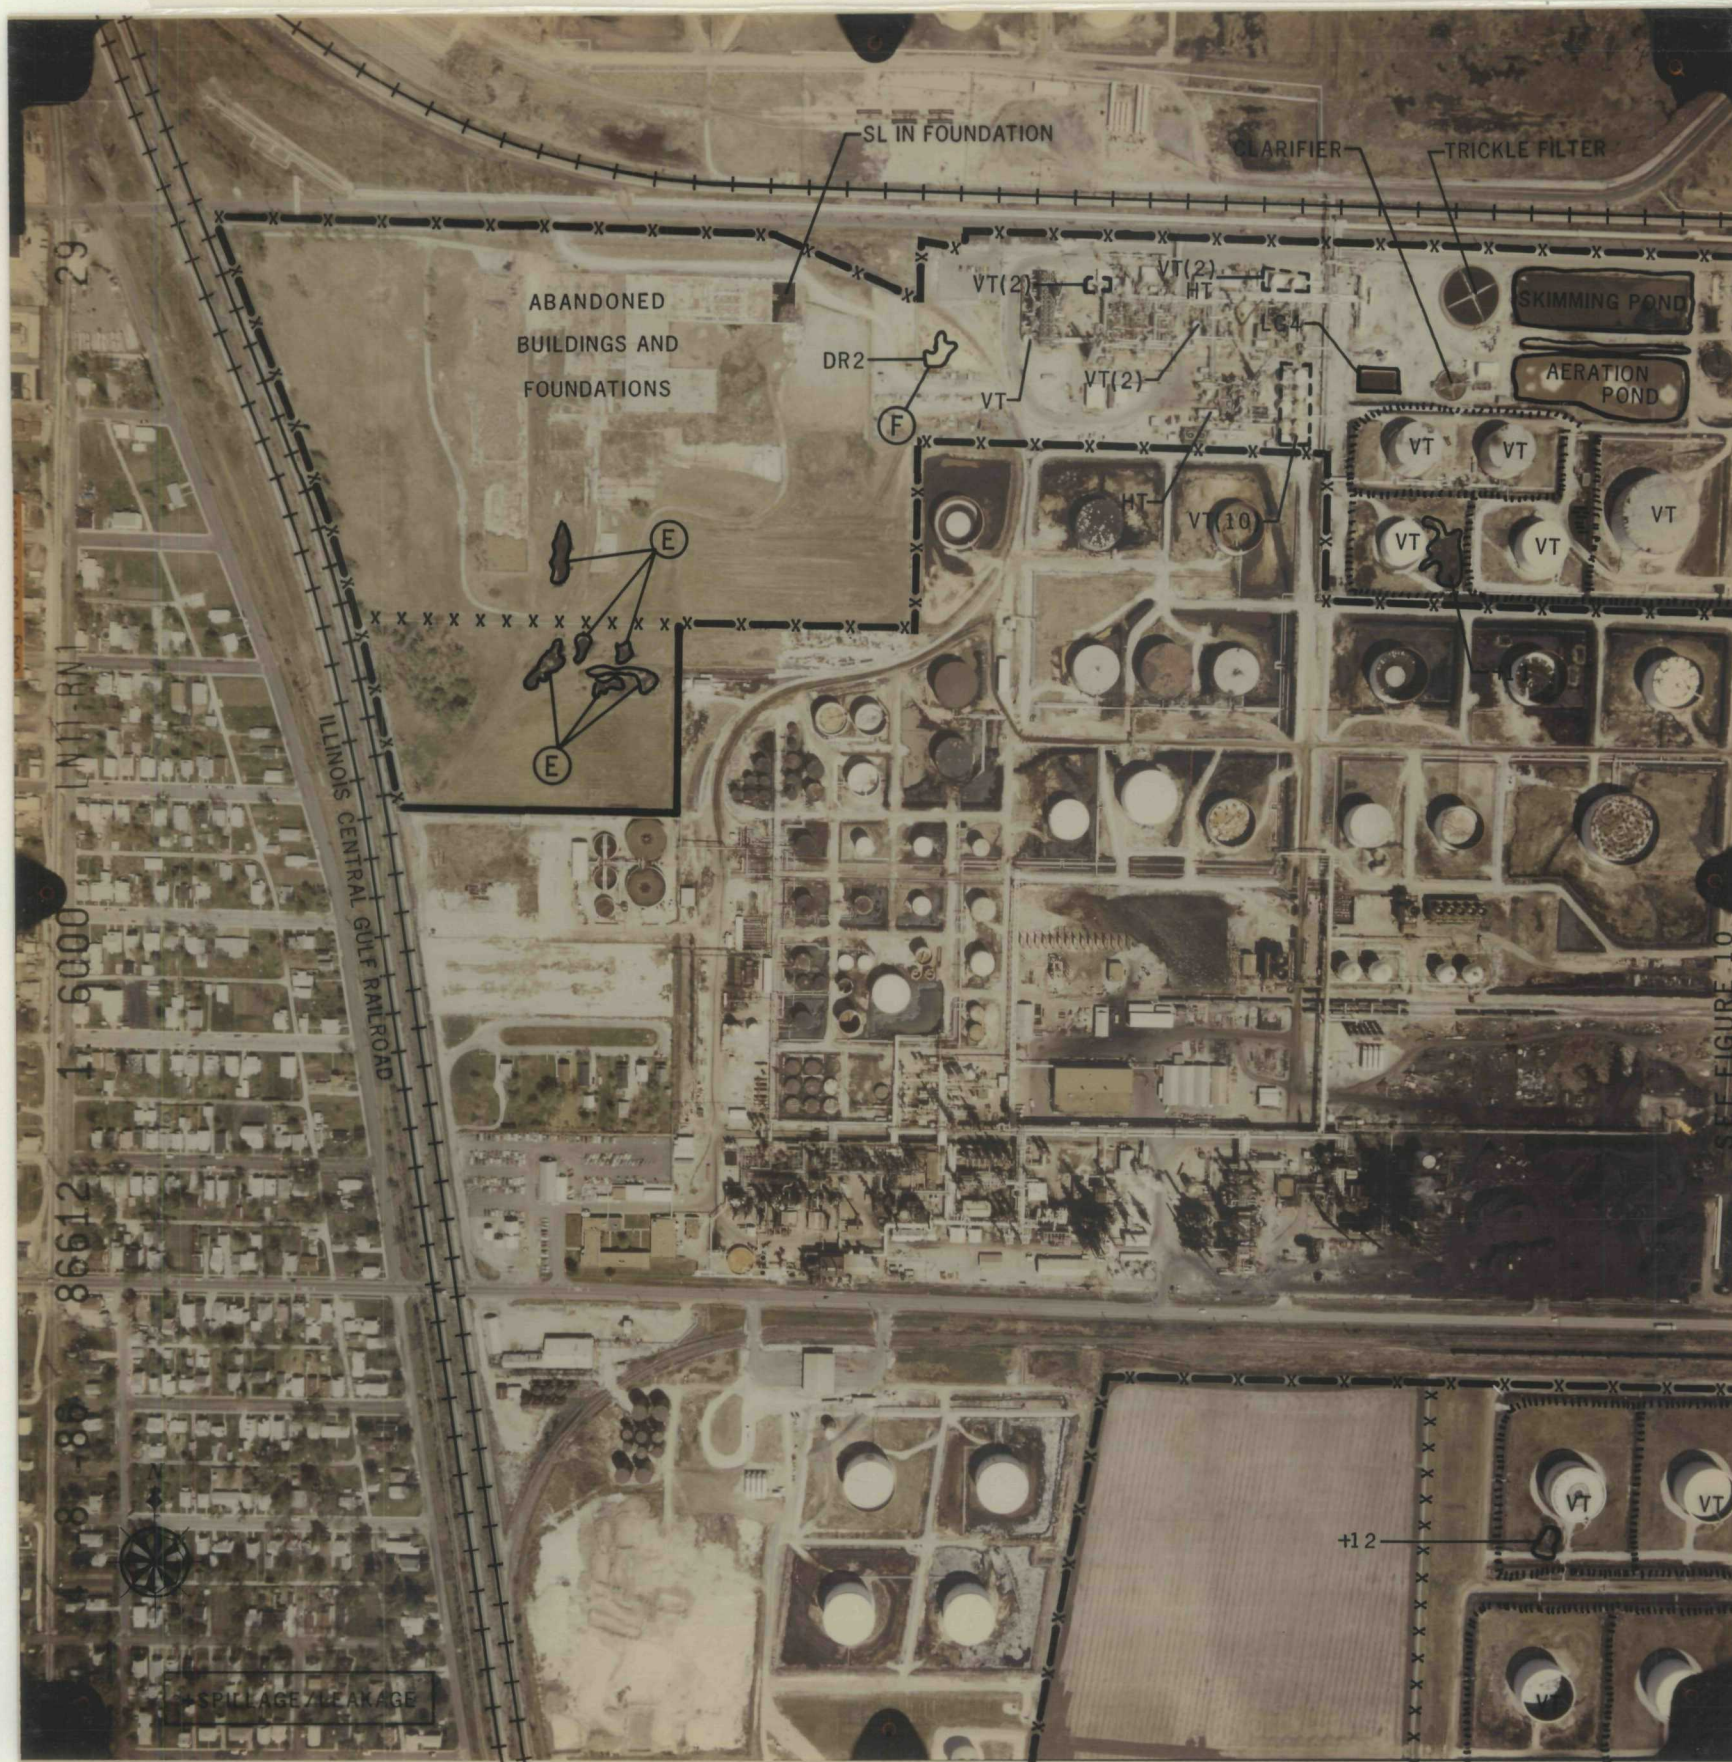
Figure 9. Shell Refinery site, April 8, 1986 (6 of 9). Approximate scale 1:6000.

Figure 9 shows the southwest corner of the site. Fencing in this area is adequate. No major drainages are present. Significant features are:

- LG4: This unlined lagoon is probably associated with waste water treatment.
- +11 and 12: Adjacent tanks are the probable source of these dark oily spills inside containment, although no signs of leakage are observed.
- Annotation E: These are dark-black areas south of abandoned buildings. The nature or source of these features is not apparent.
- Annotation F: This mound of yellow solid is probably sulfur.
- DR2: Approximately 15 drums are at this location. No leakage is visible.

Additional features shown on this frame are skimming and aeration ponds and other waste treatment structures.
